Confidential Inspection Report

5382 Roberts Ave
Lewiston, NY 14092

May 12, 2017

RADON SCREENING

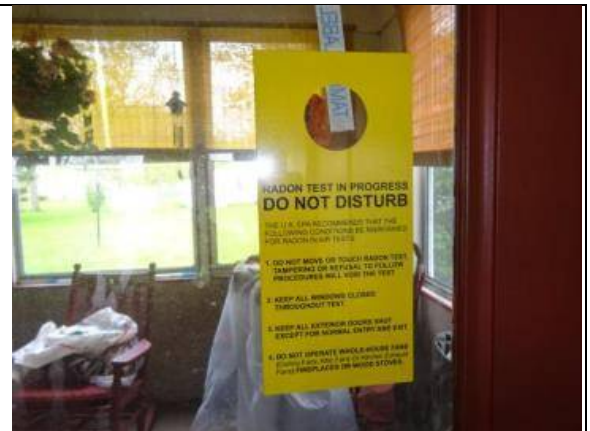
Yes, a radon test in progress sign was posted in a conspicuous area of the structure. This notice also contained a listing of the testing conditions.

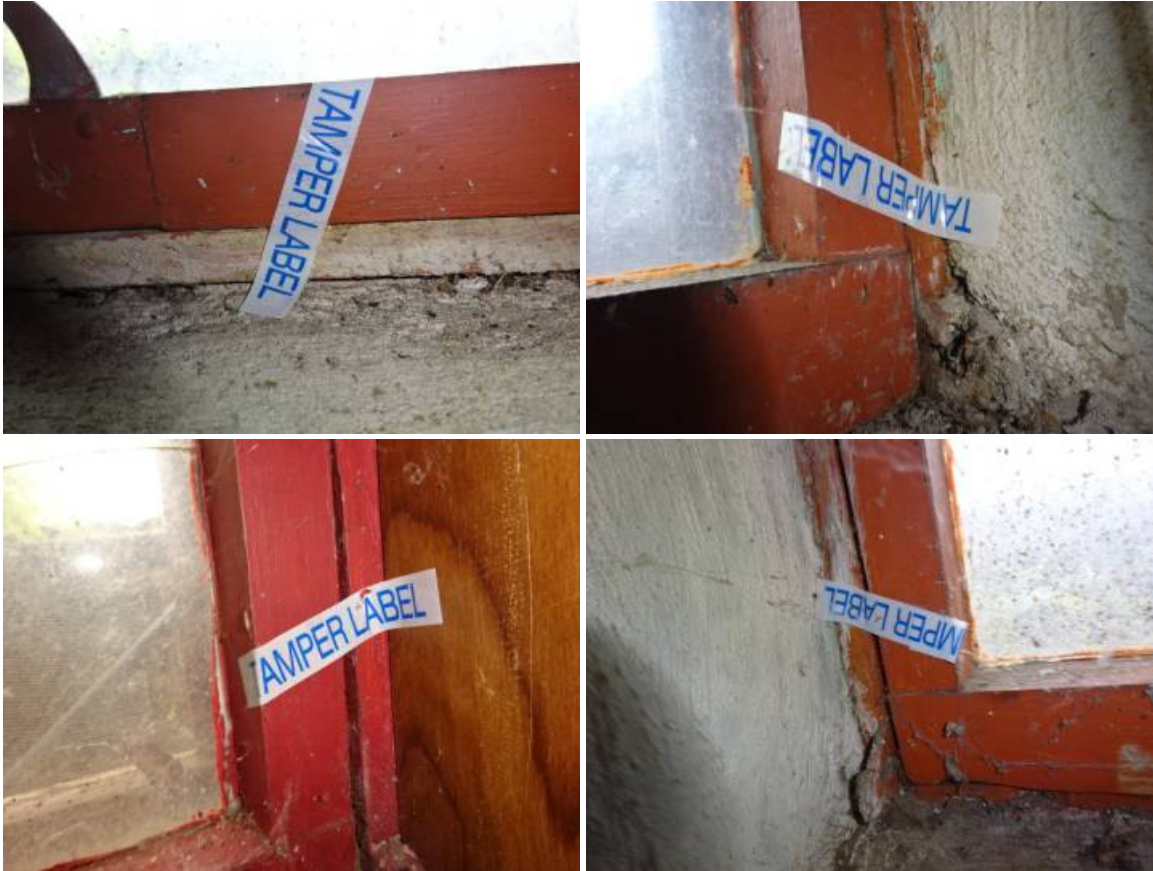
The windows and non-essential doors were sealed or tagged(BASEMENT WIDOWS ONLY)

None of the installed seals were disturbed.
